# An Ultraconservative Technique for Restoring a Missing Central Incisor

Richard M. Parker, DDS, FAGD

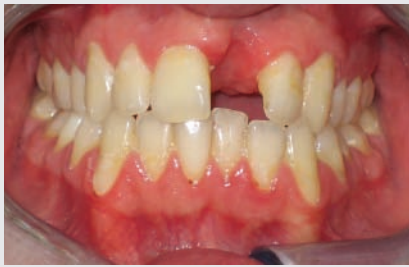
**Figure 1**—Retracted view after orthodontic alignment of tooth No. 10 and before connective tissue graft.

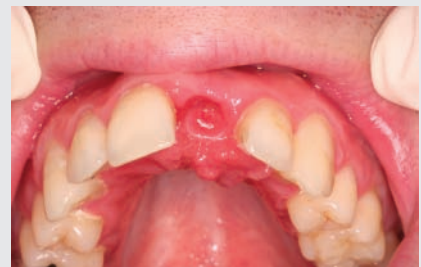
**Figure 6**—Healing of pontic site after initial tissue contouring.

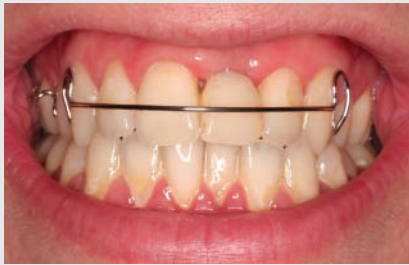
**Figure 7**—Healing complete after initial soft-tissue contouring; denture tooth and gingival need additional shaping for esthetics.

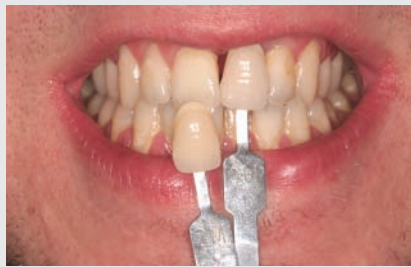
**Figure 13**—Shade taking for bridge with Vita 3D tabs.

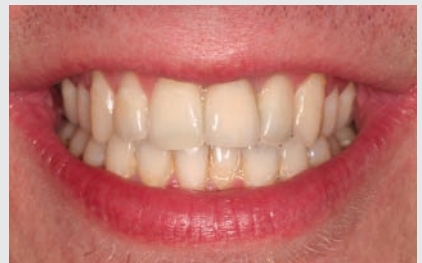
**Figure 18**—Three weeks after delivery of bridge; smile view.
